Manhole Inspection Summary

Manhole # S43EE_039MH

Insp Date: **12/20/07 8:34 AM**

Location Address: **rutland av**

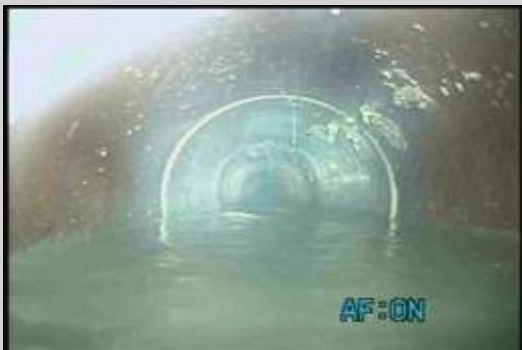
12 O'Clock Outflow

10 in. Circular Gravity Sewer
Pipe Out @ 12 O'Clock

Pipe Material: **Clay** ☐ Pipe Lined

Invert Depth: **16.20** (ft.) Flow Characteristics: **Slow**

Deposits: ☒ None ☐ Mud ☐ Sludge ☐ Debris ☐ Grease

Infiltration: **None** Pipe Seal Cond: **Unknown**

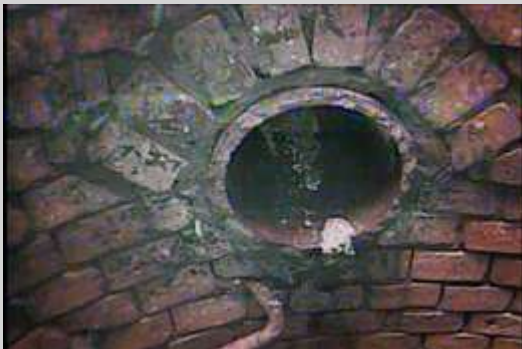
3 O'Clock Inflow

8 in. Circular Gravity Sewer
Pipe In @ 3 O'Clock

Pipe Material: **Clay** ☐ Pipe Lined

Invert Depth: **10.10** (ft.) Flow Characteristics: **Slow**

Deposits: ☒ None ☐ Mud ☐ Sludge ☐ Debris ☐ Grease

Infiltration: **None** Pipe Seal Cond: **Unknown**

Drop: **Outside**

Drop Condition: **Open**

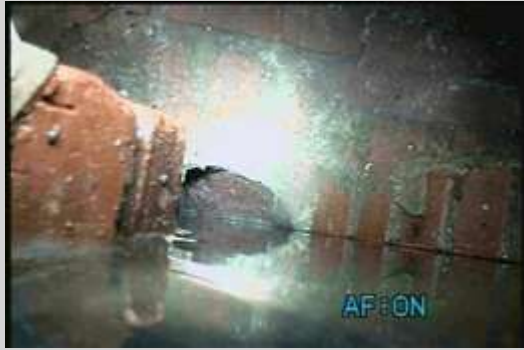
9 O'Clock Inflow

8 in. Circular Gravity Sewer

Pipe In @ 9 O'Clock

Pipe Material: **Clay** ☐ Pipe Lined

Invert Depth: **16.00** (ft.) Flow Characteristics: **Slow**

Deposits: ☒ None ☐ Mud ☐ Sludge ☐ Debris ☐ Grease

Infiltration: **None**
